CLIENT PROJECT REPORT 1730

Parkhurst Road, Islington - PERS audit report

Prepared for: Transport Planning Practice Ltd

Project Ref: 11199208/14

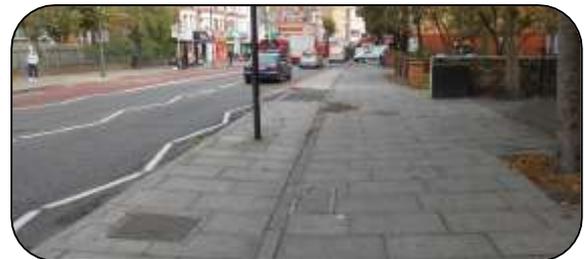
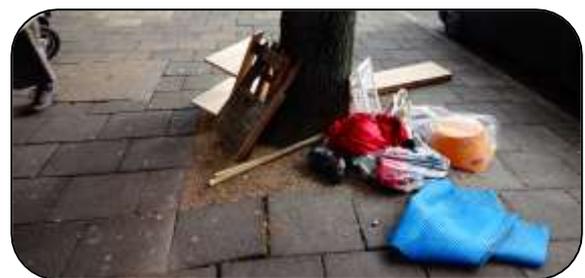
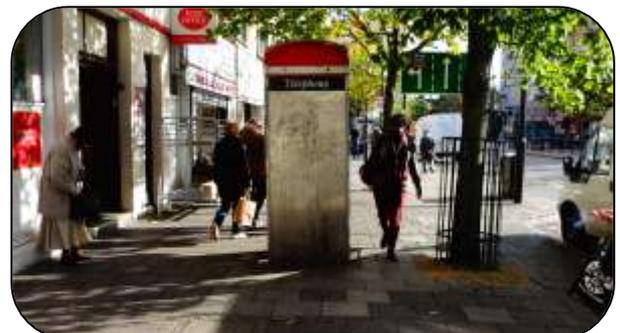
- There was a lack of **colour contrast** or tonal contrast along certain links with no differentiation between tactile paving and surrounding paving. Colour contrast aids in the navigation, orientation and protection of hazards for partially sighted pedestrians. An obstruction will therefore represent a hazard rather than an inconvenience.
- **Maintenance** and cleanliness was considered to be low in some areas. This is mostly due to litter, seasonal foliage and gum stains.
- In some locations the footway was narrowed due to the presence of **obstructions** such as A-boards and telephone boxes which are badly positioned. Narrow footways are more likely to become congested at peak times. In most cases there are no tactile warnings provided when encountering an obstruction which has the potential to cause harm, particularly to vulnerable users.

The lack of colour or tonal contrast was identified along a number of links, with no differentiation between the tactile paving and the surrounding paving. It is recommended that colour contrast is provided to aid in the navigation, orientation and protection of hazards particularly for partially sighted pedestrians.

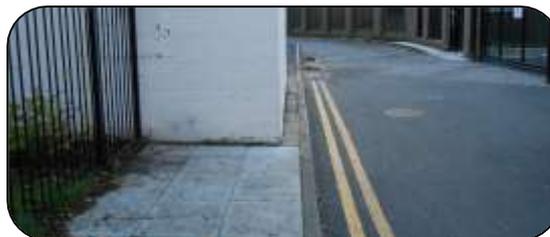
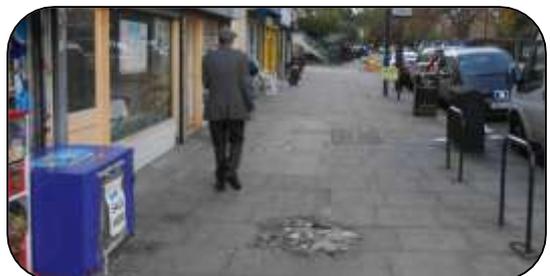
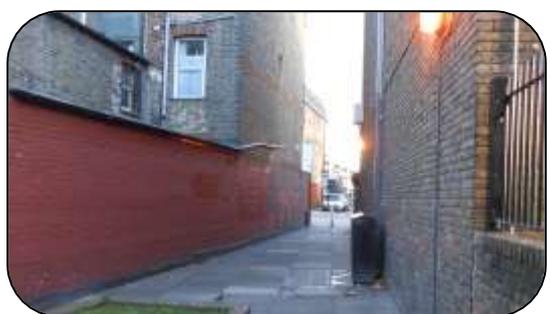
- The **effective width** of footways was substandard or non-existent along some links. This raises safety issues since pedestrians are forced to walk in the carriageway.
- The **permeability** along some links received low scores due to a lack of crossing points and a lack of dropped kerbs. A number of crossing points with suitable dropped kerbs are often required to provide safe entry and exit to and along the link.
- **Personal security** was considered to be low along some links, with a lack of CCTV, poor lighting levels and a perceived sense of crime. This can raise safety concerns for pedestrians using the footway.

As part of the proposals, it is recommended that the quality of the footways surrounding the proposed development is upgraded to address surface quality issues. A smooth and clean footway surface should be provided and potential slip and trip hazards should be removed where possible.

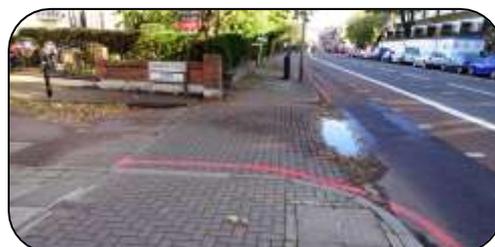
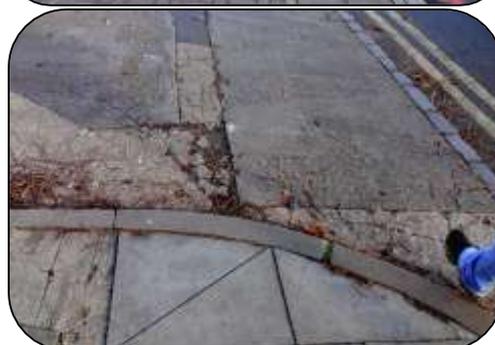
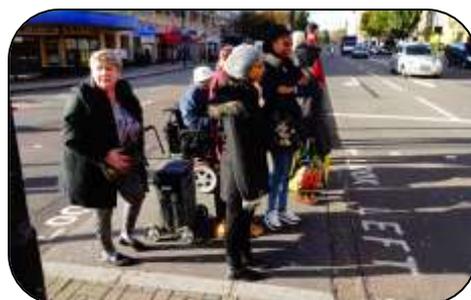
- The **surface quality** is poor in places with trip and slip hazards and uneven and cracked surfaces being reported. Inconsistent surface materials are used in some areas which varied in quality, and at some crossings there were poor reinstatements and areas of ponding which represented a trip or slip hazard.

- There was a considerable amount of **delay** at some of the crossings, particularly at staggered crossings, when the waiting time to cross seemed to be quite long. At times, this encouraged pedestrians to cross the road before the green man signal which raises safety concerns.

- The **legibility** at crossings was scored negatively at some locations where there was a lack of delineation and driver stop

line, and it was not obvious where to cross. Coloured surfacing and markings should be used where appropriate to delineate a safe crossing.

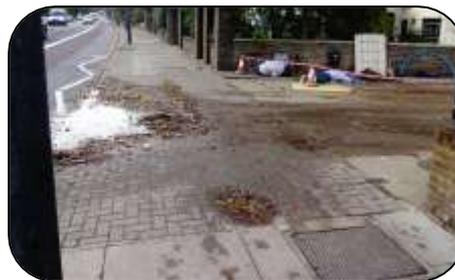
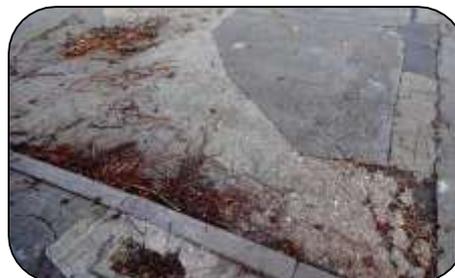
- Maintenance** and cleanliness is considered to be low in some areas. This is mostly due to leaf litter, littering and a poor state of repair. Increased street cleaning would improve the upkeep of the pedestrian environment.

A number of links and crossings were observed on site to be littered by seasonal foliage, with ponding occurring in some places. It is recommended that increased street cleaning takes place to clear the footways of litter and seasonal foliage. It should however be noted that the day before the audit was undertaken there were some adverse stormy weather conditions, which might explain the levels of seasonal foliage that were observed to be littering the footways.

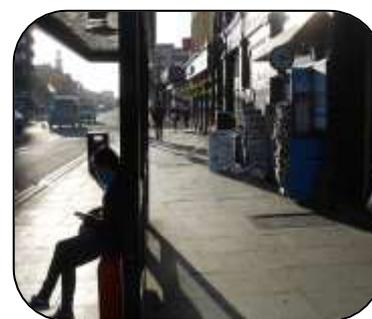
- The interchange could have scored more highly if there was a larger waiting area and if more seating was provided either within or outside the station. The removal of the advertising boards outside the adjacent shops could improve the quality of the interchange environment.

ID	Facility Name	Recommendations
I1	Holloway Road Underground Station	Enhanced street cleaning in the space.

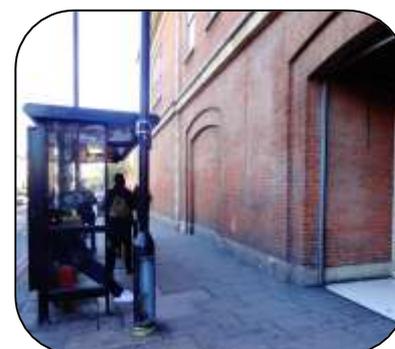
- Bus Stop R scored poorly on security measures because there was no evident CCTV within the vicinity of the bus stop and there was little opportunity to report incidents, being located next a relatively busy road.

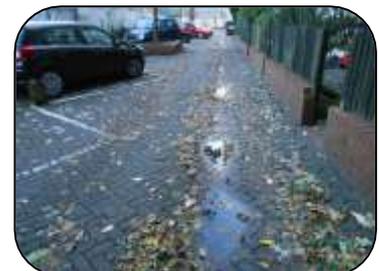
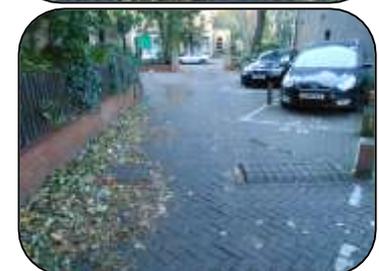
- Route 4 received red RAG ratings for **road safety** and **personal security**. This is because there is no footway alongside McCall House which means that pedestrians are forced to walk through the car park. There are speed humps within the car park which cause a barrier to pedestrians and the area feels rather unsafe due to insufficient lighting and a lack of formal surveillance.
