**ARBORICULTURAL  
IMPACT ASSESSMENT**

**65-69 PARKHURST ROAD,  
LONDON**

A Report to Parkhurst Road Limited

Report Number: RT-MME-115349-05

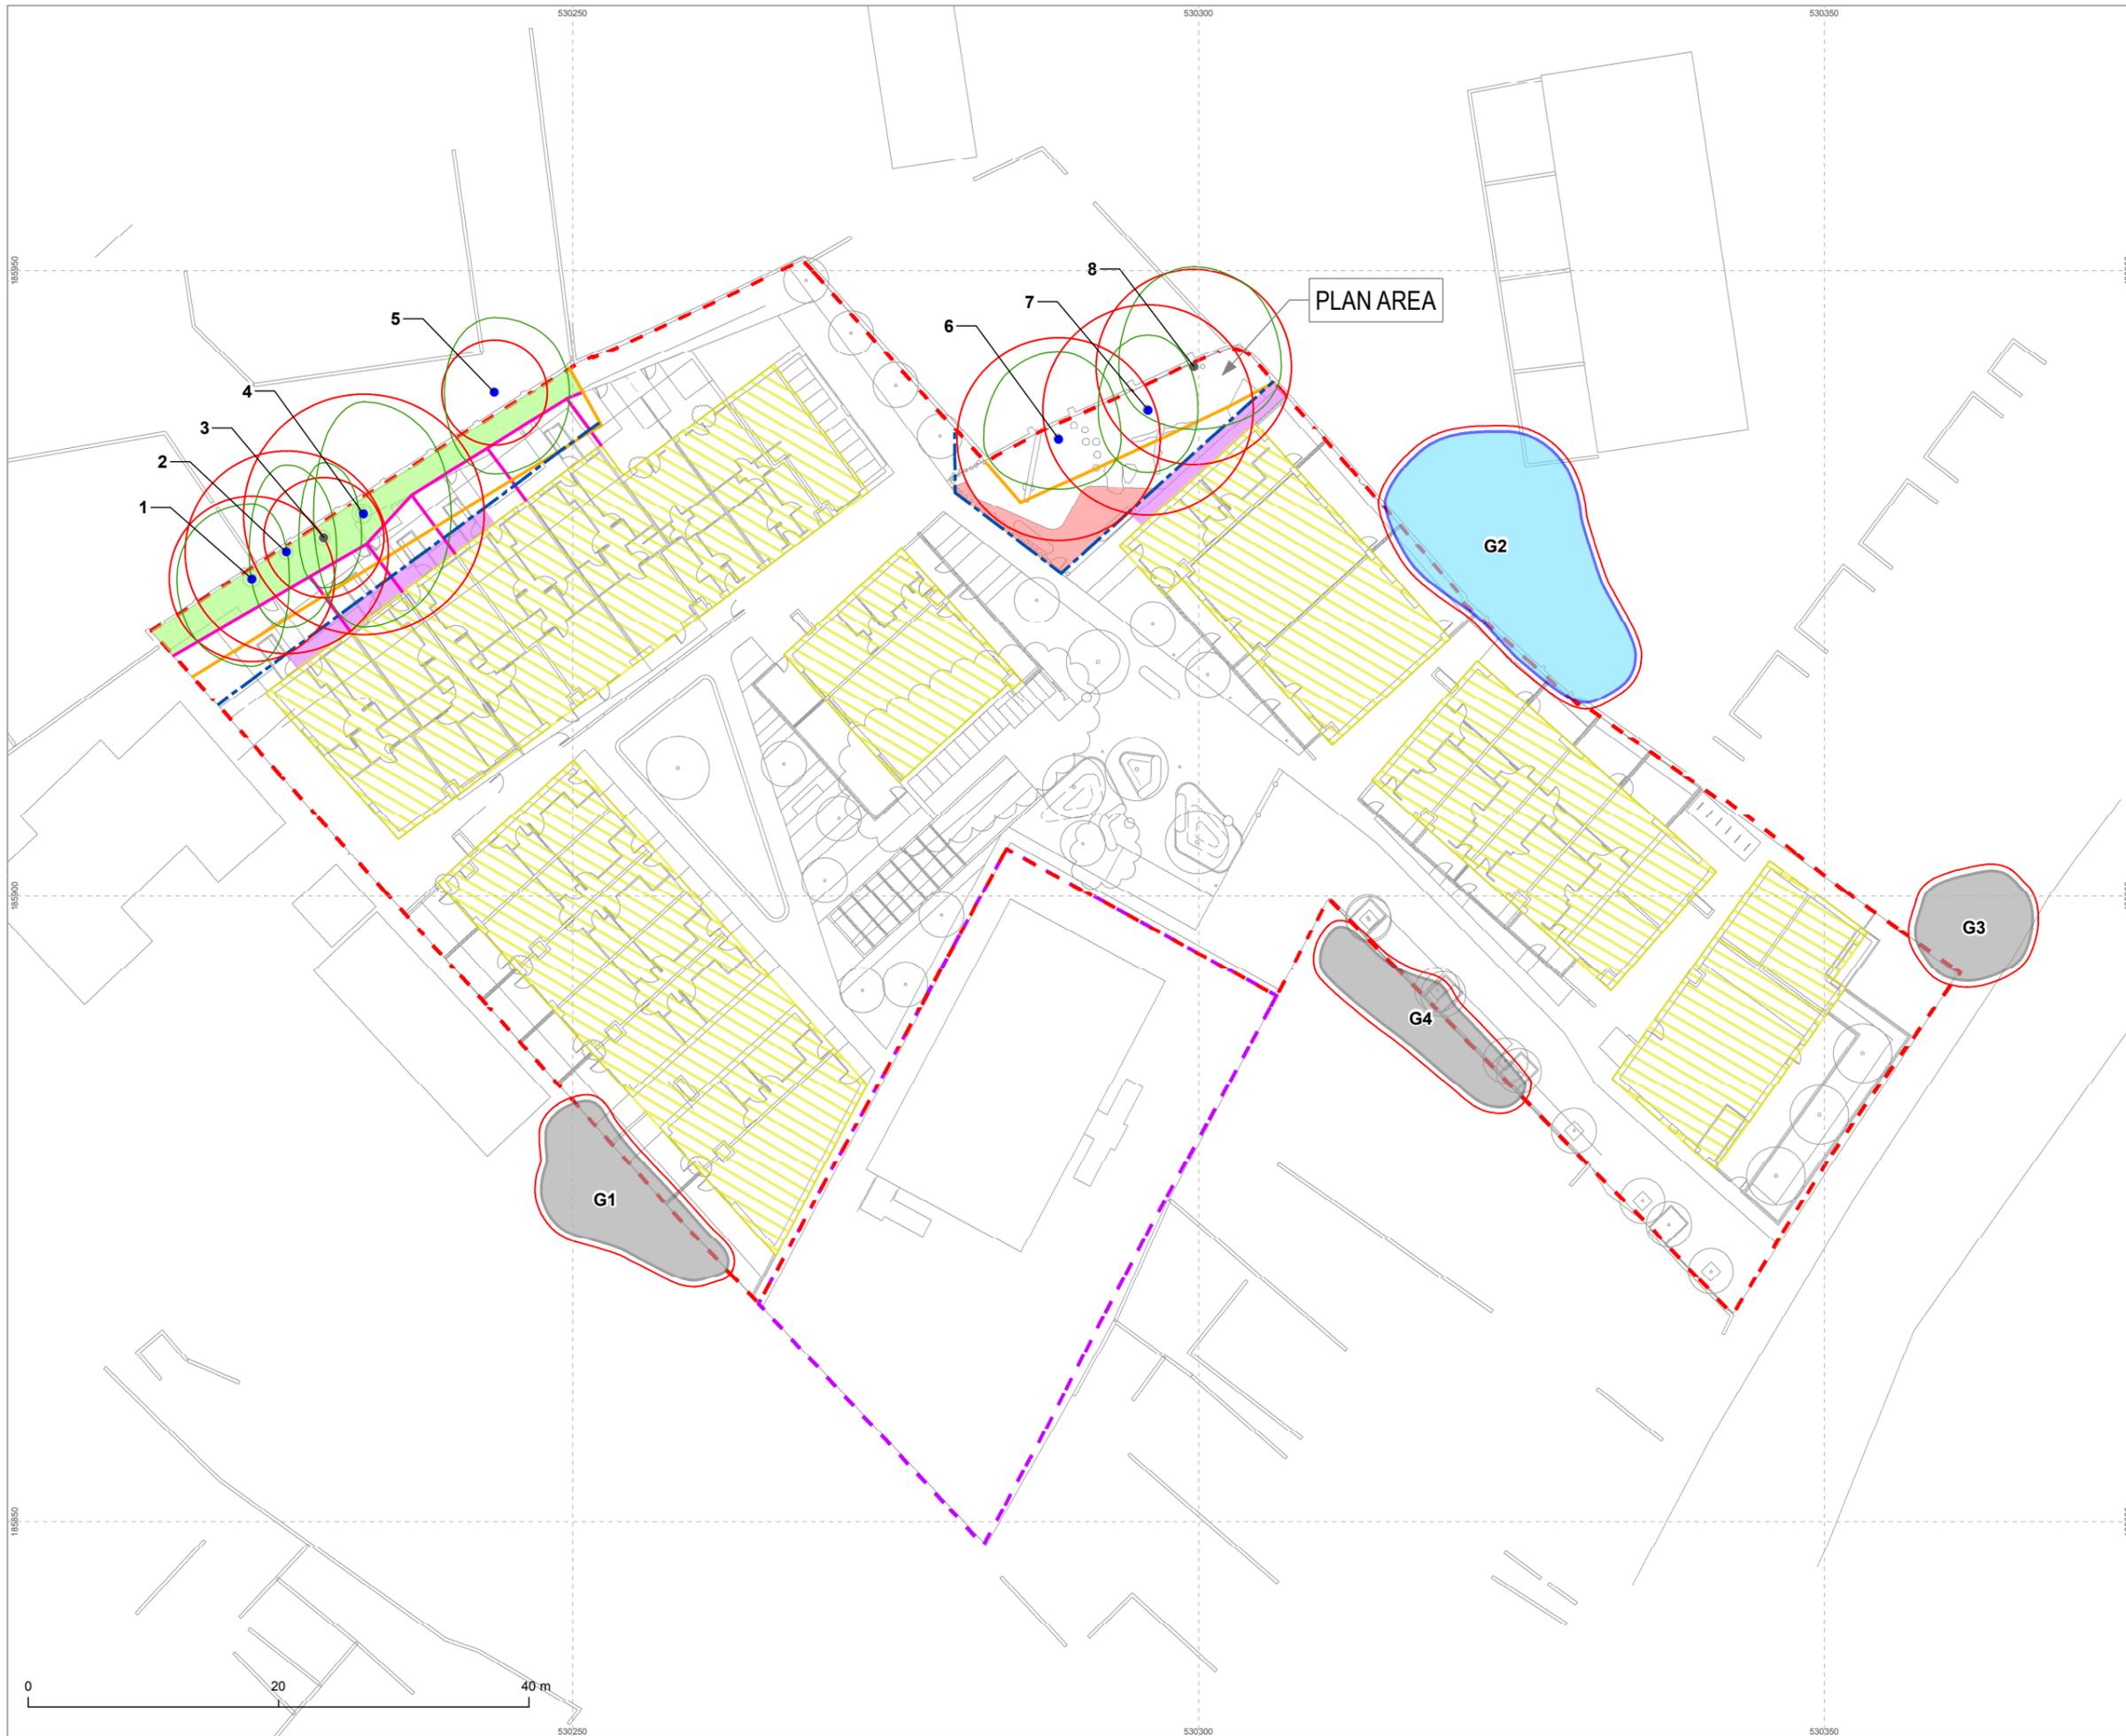
Drawing Number C115349-05-01- Draft Tree Protection Plan

Drawing C115349-05-01 provides a draft Tree Protection Plan indicating the potential location of protective barriers and ground protection.

Trees should be protected by the installation of tree protection barriers as shown on draft Tree Protection Plan (Drawing Number C115349-05-01). Hard surfacing should be retained where it is laid over the RPAs to provide ground protection during this exercise.

Once the hard surfaces have been removed the protective fencing should be relocated to the 'Phase 2' construction position (see the Draft Tree Protection Plan, Drawing Number C115349-05-01).

To protect the trees and allow for the necessary access for construction, tree protection barriers should be erected to provide construction exclusion zones. The proposed location of the tree protection barriers are shown on draft Tree Protection Plan (Drawing Number C115349-05-01).
