Arboricultural Impact Assessment and method statement

Parkhurst Gardens
The former Territorial Army Site
65-69 Parkhurst Road
London
N7 0LP

Client: Parkhurst Road Ltd

June 2014

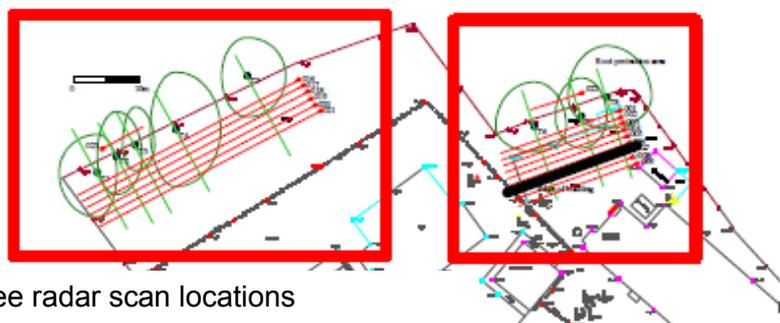
4.2 The TreeRadar survey found that the trees are rooting at expected densities in the site, reducing in density the further away from the wall, most markedly in T1—T5. The walls do not act as a root barrier. Roots are tracking down on the interface of the wall and soil to exploit the condensation layer from the temperature differential between the brick and soil and also gaining 'purchase' from the wall structure. They then continue the other side to the play area and to the allotment garden. Most of the rooting is below 800mm below the fill beneath the tarmac.

Image 1—tree radar scan locations

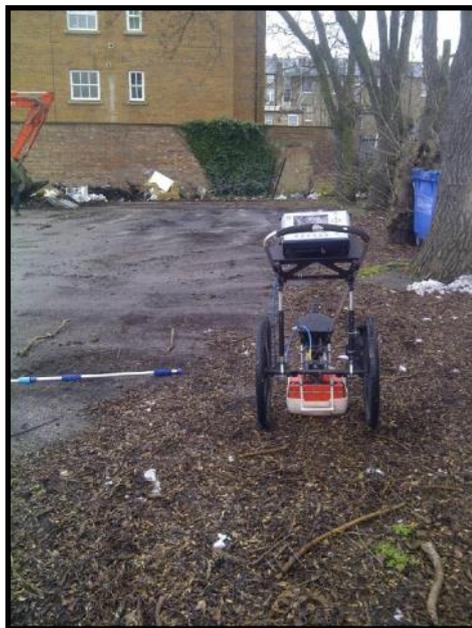
Photo 1 view of the rooting area of T1—T5 looking west

This area will be bark mulched, not surfaced with benches as shown

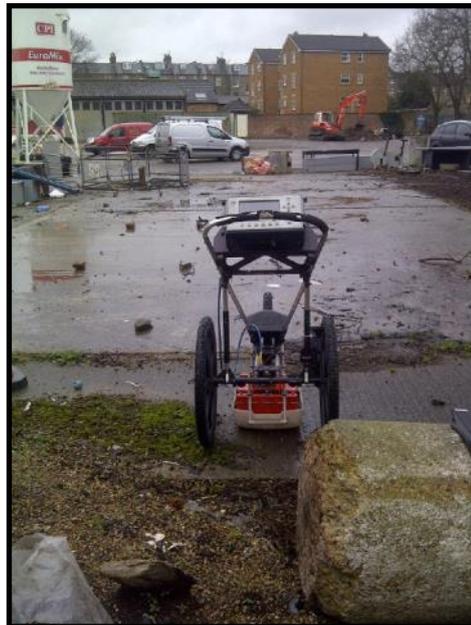
Photo 2 view of the rooting area of T6—T8 looking west

5.3 The treatment near T5—T8 is similar.

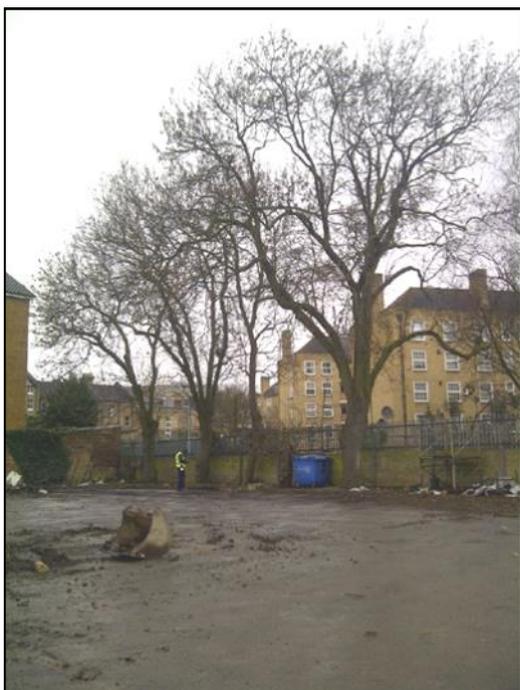
1. T1 - T5 looking west along the northern boundary

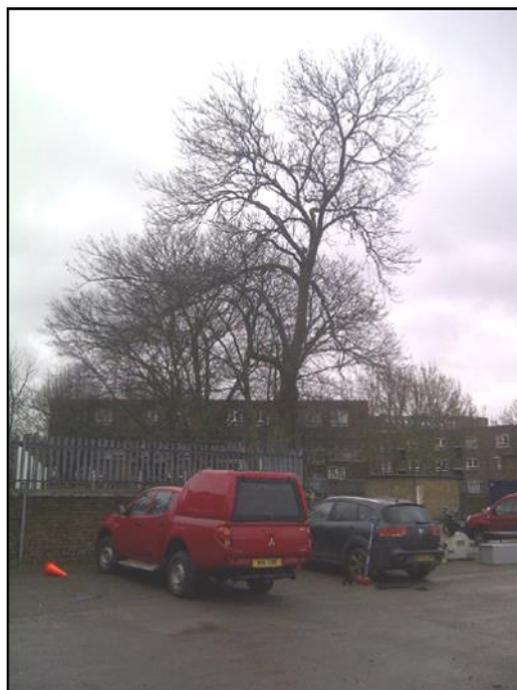
2. T6—T8 looking east

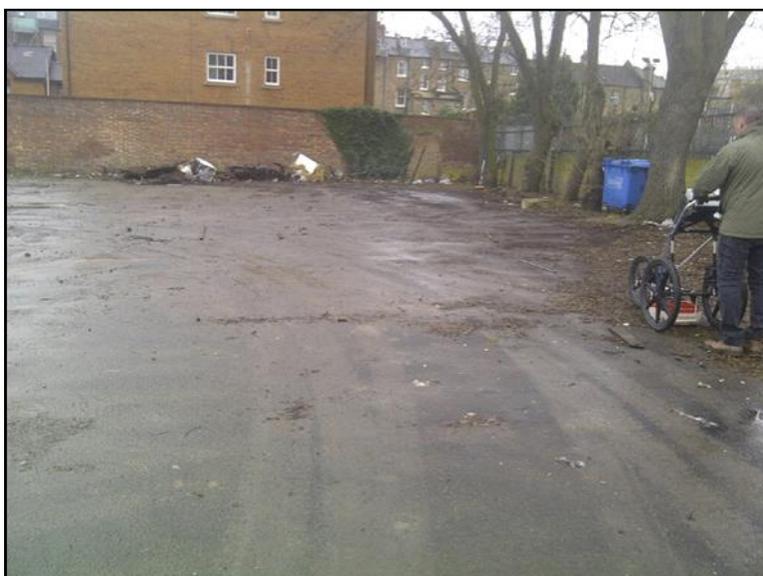
3. General view of rooting area which is common to T1—T8
