CLIENT PROJECT REPORT 1730

Parkhurst Road, Islington - PERS audit report

Prepared for: Transport Planning Practice Ltd

Project Ref: 11199208/14

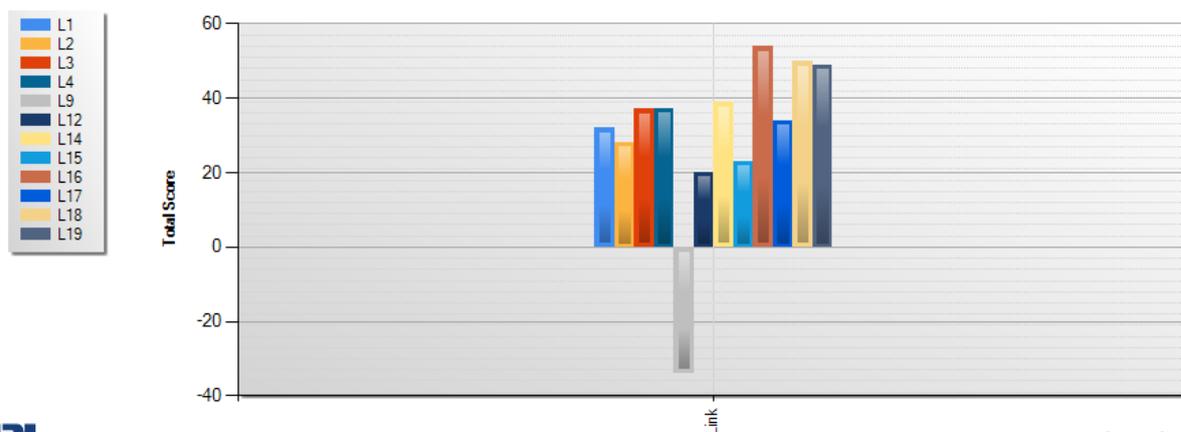
Figure 1: Total Scores for Audited Links

As shown, the total weighted scores for the links ranged from +54 (Link 16) which was along the western side of Holloway Road to the north of Tufnell Park Road to -34 (Link 9) which was along Holbrooke Court.

Link 9 (Holbrooke Court) was the only link which scored negative results overall. It scored particularly low scores for **effective width, obstructions, permeability, personal security, quality of environment and maintenance**. The link is currently narrow with a lack of dropped kerbs and substandard in places, and has obstructions at its northern and southern end. It is poorly maintained and feels rather unsafe due to the low lighting levels and lack of CCTV. Whilst very low pedestrian and traffic flows were observed on site, the link could be improved to better provide for pedestrians particularly if it is expected to be used more heavily as a result of the proposals.

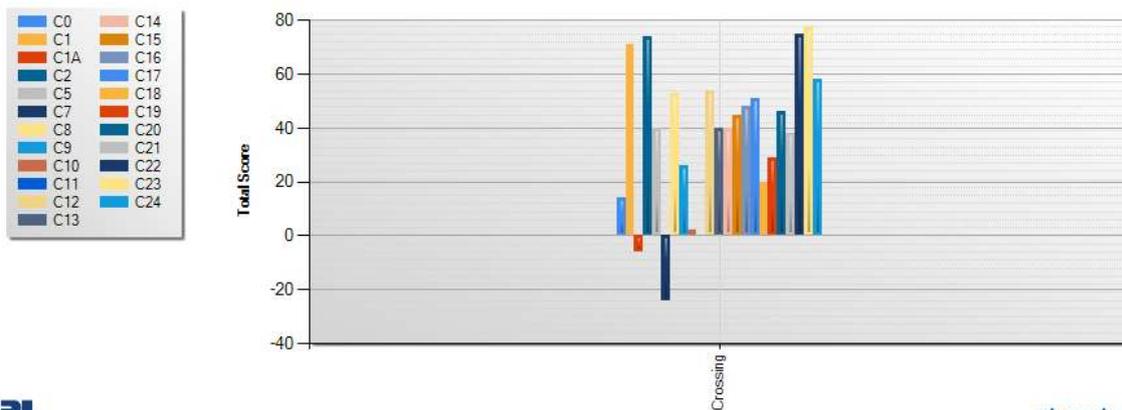
Figure 3: Total Scores for Audited Crossings

As shown, the total weighted scores for the crossings ranged from +78 (Crossing 23) which was crossing Hercules Place on the northern side of Seven Sisters Road to a score of -24 (Crossing 7) which was a footway crossover at the entrance to a private car park on the northern side of Tufnell Park Road. The two crossings which scored negative results overall are discussed below:

- Crossing 1A (Footway crossover at the site access on the northern side of Parkhurst Road) scored -6 overall. It scored particularly low scores for **legibility, legibility for sensory impaired people, surface quality and maintenance**. The crossing currently has an uneven surface which results in ponding and a collection of leaf litter and there is a lack of tactile information present. As a result of the proposals, the existing site access (Crossing 1A) is being retained as the main pedestrian, cycle and vehicular access into the site. It is understood that this access will remain in roughly the same position but will be 'shared surface' to encourage low vehicle speeds. The proposals are therefore expected to improve the existing crossing provision that was observed on site.

- Crossing 7 (Footway crossover at the entrance to a private car park on the northern side of Tufnell Park Road) scored -24 overall. It scored particularly low scores for **deviation from the desire line, legibility, dropped kerbs, obstructions, surface quality and maintenance**. The dropped kerbs on either side of the crossing were not aligned and there were black bollards which caused deviation from the pedestrian desire line and caused an obstruction to cross. The road surface was of poor quality and there was a lack of tactile information. Whilst the private car park is expected to generate very low traffic flows, the crossing could be improved to better provide for pedestrians. Due to its location on the northern side of Tufnell Park Road, the proposed development is not expected to affect the existing usage of this crossing.
